About Lorbrand Material Solutions

A little bit about our conveyor belt repair kits:

QIK FIX CONVEYOR BELT REPAIR KIT (1050G)

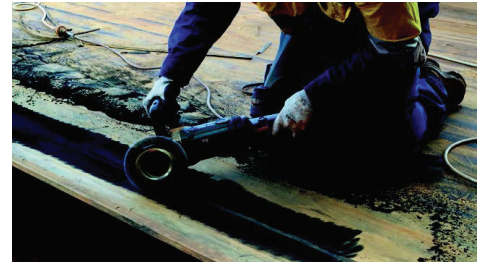
Step 1

Prepare surface – clean and grind out the repair area with a wire brush/wheel. Ensure a profile in the rubber is produced.

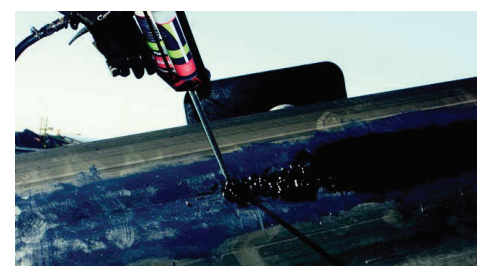
Step 4

Repair the surface – once the second coat of the Primer No.6 is tacky, fill the repair area using Lorbrand's conveyor repair kit.

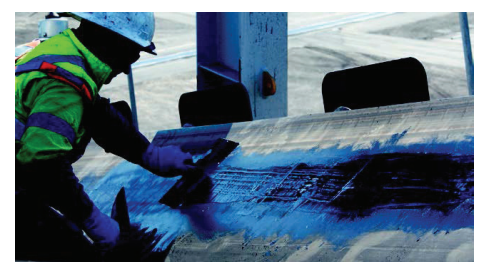
Step 5

Finish the surface – use a scraper blade to smooth out the material to the repair area and feather out the edges (no need to buff once completed).

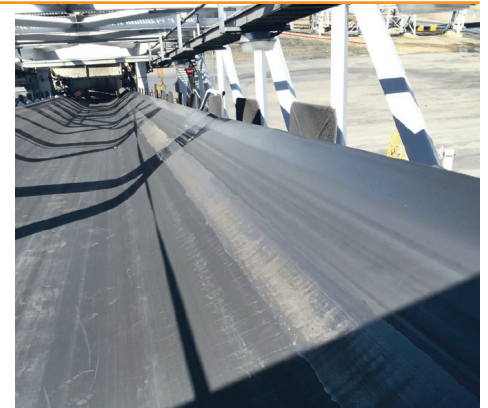
SITUATION: A large rock was lodged between the hard skirt and the belt for a period of time. As a result, this wore a 100mm (W) x 12mm (D) groove along the entire length of the belt down to the steel cables.

RESULT: Estimate cost to replace the steel cable belt - \$270,000

Cost to repair the belt - \$35,000
